Document Nr.: PR3-DARA-RT-0066

Date: 02.02.2018

DARA

Controller Board Irradiation Test Report

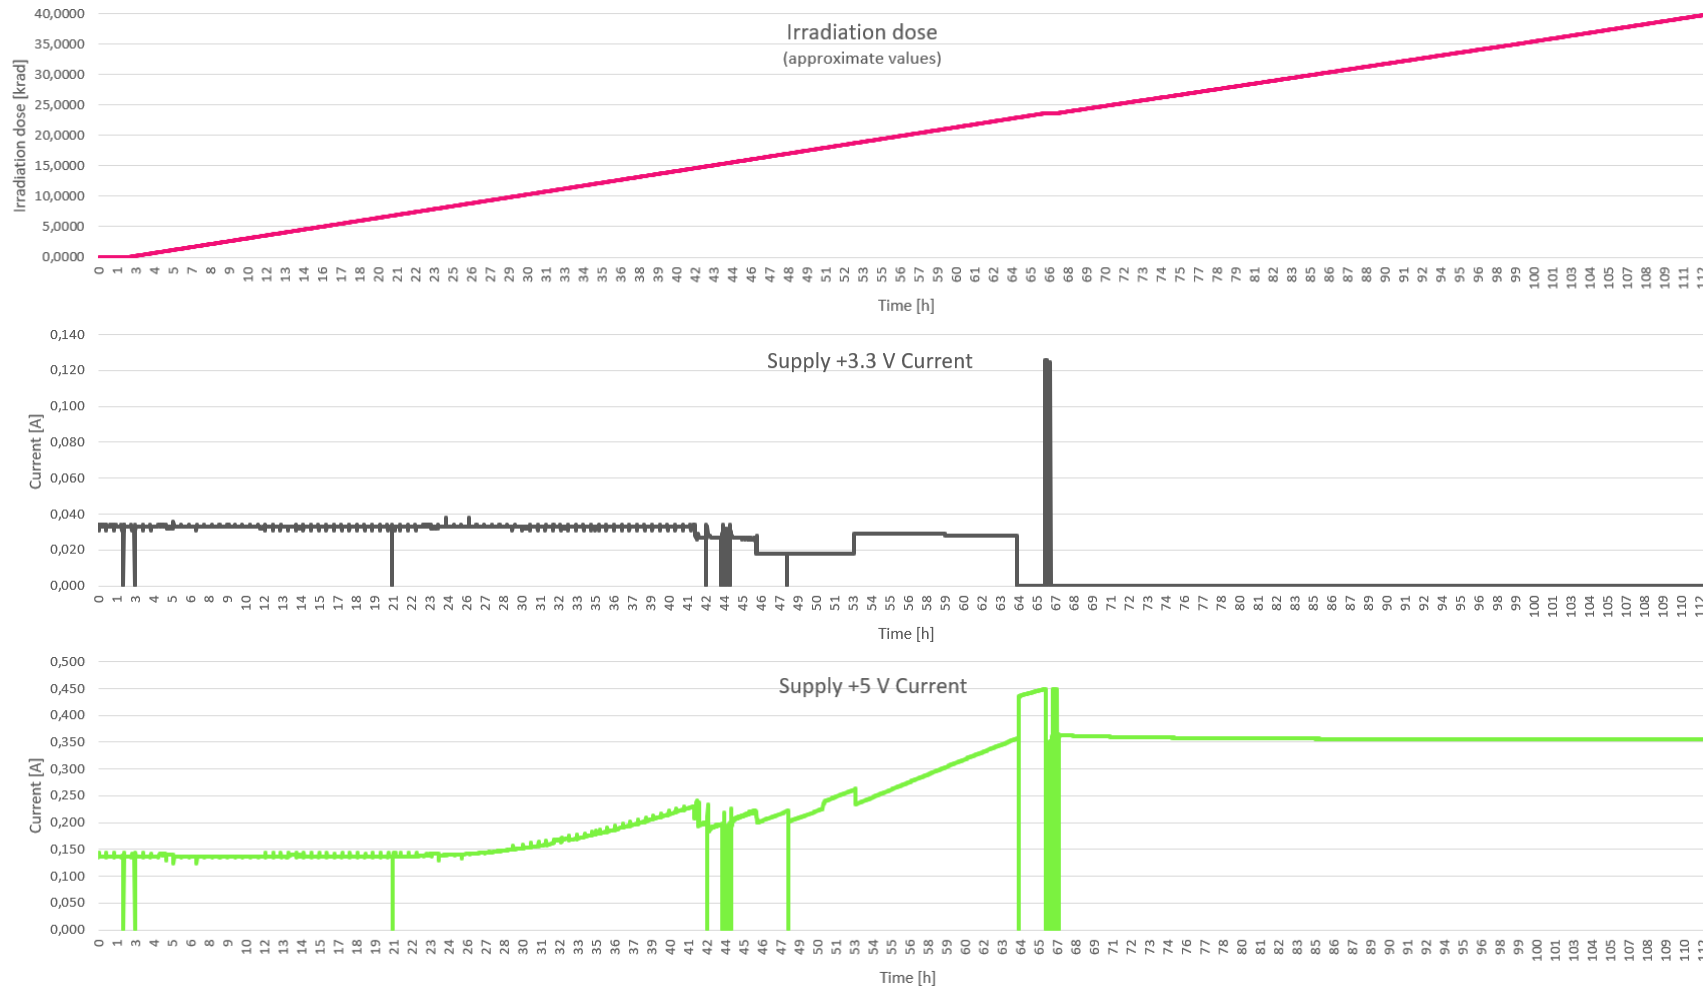
The +5V supply started increasing at ~ 7.5 krad. The CPU failed at an irradiation dose of ~ 14.6 krad.

The +5V current consumption was drifting while irradiation, from 136 mA to 450 mA in maximum.

The following graphs show the drift of the digital power supplies over the irradiation test. If there is a peak going to zero, this means, the supply was switched off temporarily.

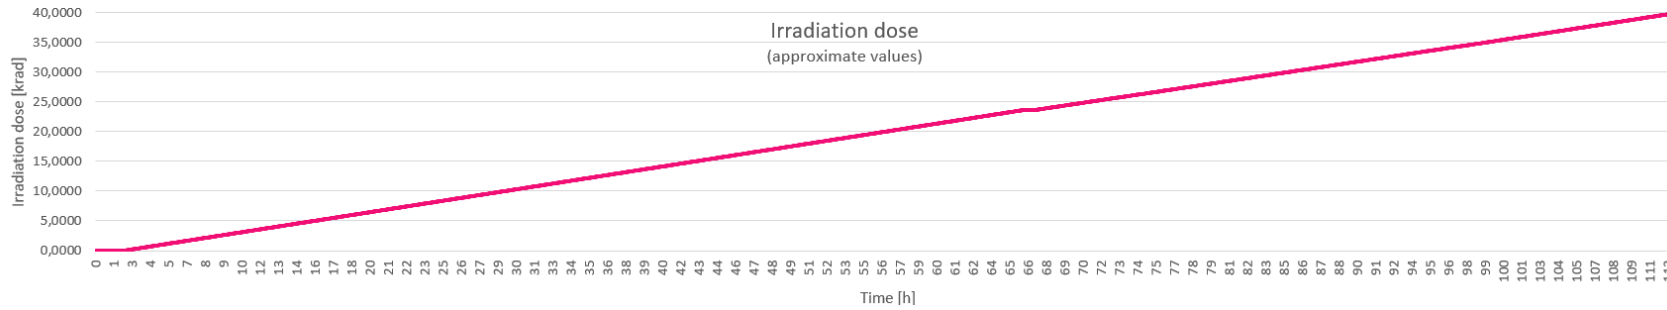
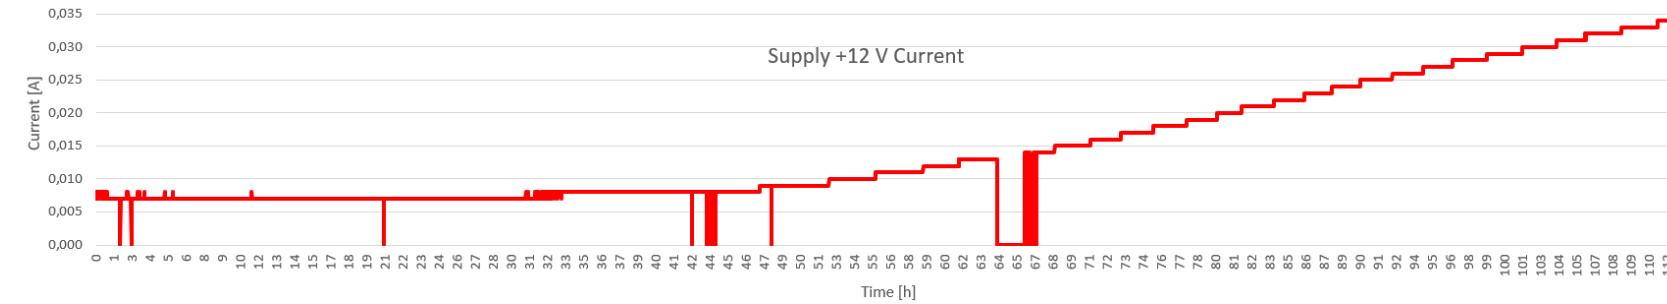
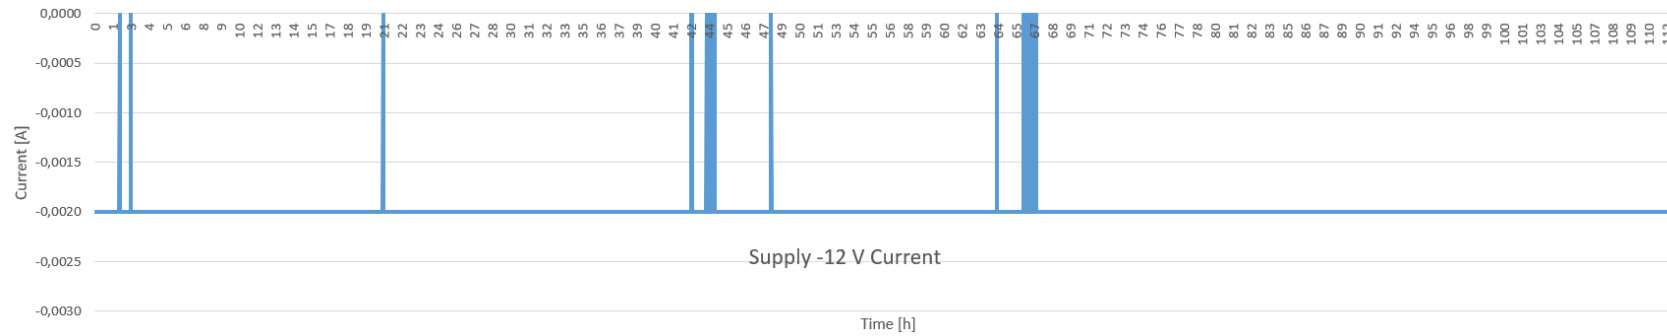
The current consumption of the +12V power supply was drifting over irradiation test from originally 8 mA to 34 mA. The drifting started at 16.7 krad.

The following graphs show the drift of the analog power supplies over the irradiation test. If there is a peak going to zero, this means, the supply was switched off temporarily.

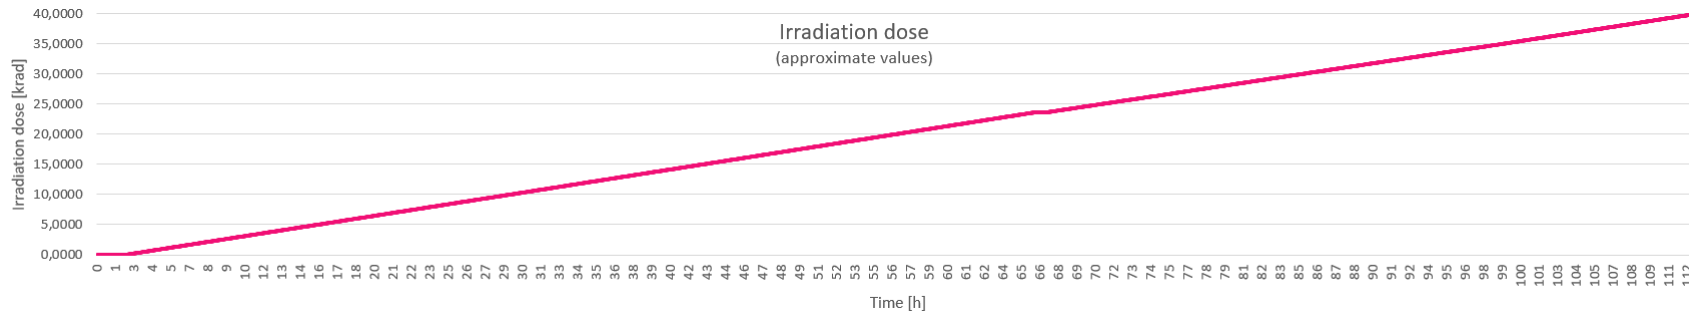
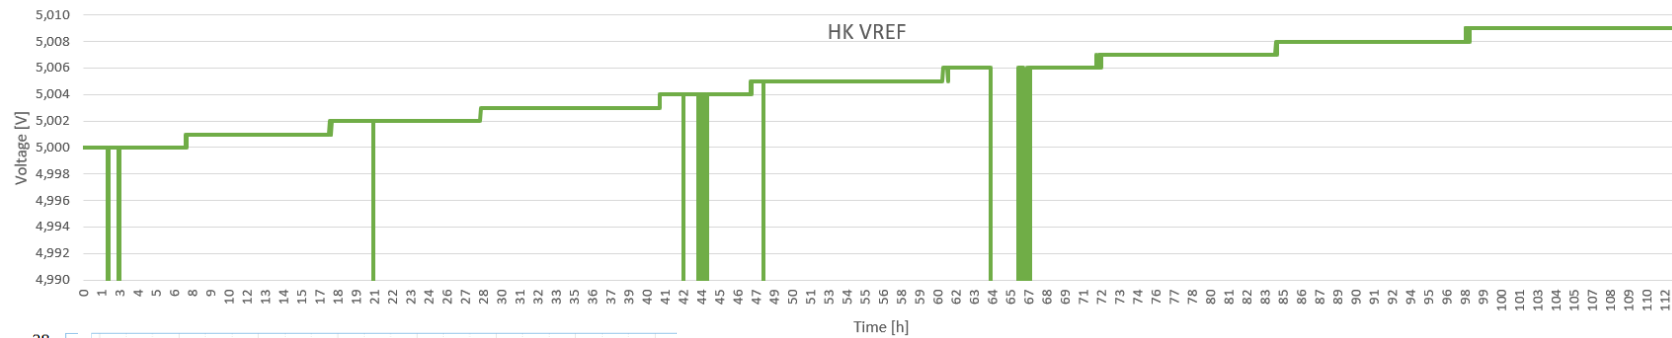
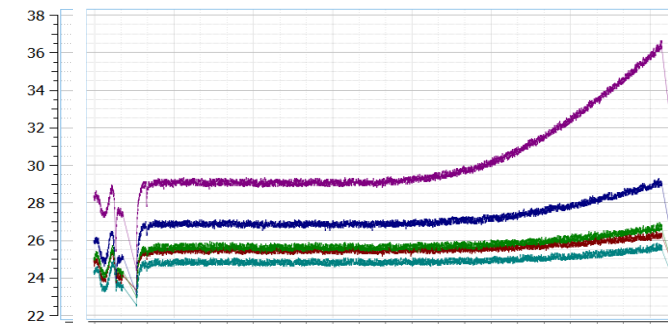
The voltage reference started drifting at ~ 1.9 krad. During the irradiation there was a continuous drifting, at the end of the test the reference voltage reached 5.009 V at a dose of 40.1 krad.

The following graphs show the drift of the reference voltage over the irradiation test. If there is a peak going to zero, this means, the supply was switched off temporarily. The RTS on-board temperatures are as well showed, until the CPU failed, and no more housekeeping data was available.

5	Run, irradiation active	<p>CPU is no longer running. The CPU housing temperature raised from ~ 29.0 °C, the stabilized temperature after irradiation test was started, to ~ 36.5 °C, when the CPU failed. The increase of temperature correlated with the increase of the +5V current consumption, which is the power supply of the CPU.</p> <table border="1" data-bbox="488 499 1525 831"> <thead> <tr> <th>Signal</th> <th>Measured value</th> <th>State</th> </tr> </thead> <tbody> <tr> <td>Radiation dose</td> <td>~ 14.6 krad</td> <td>OK</td> </tr> <tr> <td>Running time</td> <td>41.5 h</td> <td>OK</td> </tr> <tr> <td>CPU</td> <td>Failure</td> <td>No more communication with EGSE</td> </tr> <tr> <td>Supply +3V3</td> <td>33 mA</td> <td>OK</td> </tr> <tr> <td>Supply +5V</td> <td>231 mA</td> <td>Further drifting</td> </tr> <tr> <td>Supply -12V</td> <td>-0.2 mA</td> <td>OK</td> </tr> <tr> <td>Supply +12V</td> <td>8 mA</td> <td>OK, increased from 7 mA to 8 mA, but stable then for long time.</td> </tr> <tr> <td>HK VREF</td> <td>5.004</td> <td>Further drifting</td> </tr> <tr> <td>ADC CLK</td> <td>9.216 MHz</td> <td>OK</td> </tr> <tr> <td>Log number</td> <td>2491</td> <td>OK</td> </tr> </tbody> </table>	Signal	Measured value	State	Radiation dose	~ 14.6 krad	OK	Running time	41.5 h	OK	CPU	Failure	No more communication with EGSE	Supply +3V3	33 mA	OK	Supply +5V	231 mA	Further drifting	Supply -12V	-0.2 mA	OK	Supply +12V	8 mA	OK, increased from 7 mA to 8 mA, but stable then for long time.	HK VREF	5.004	Further drifting	ADC CLK	9.216 MHz	OK	Log number	2491	OK
