HEAVY IONS TEST REPORT

SINGLE EVENT EFFECTS AT7913 (DC0905 - DC1229) SpaceWire Remote Terminal Controller From ATMEL

Labège, 30th January 2015 TRAD/TI/AT7913/XXX1/ESA/ELG/1211 TRAD, Bât Gallium 907, Voie l'Occitane - 31670 LABEGE France 2: 05 61 00 95 60 Fax: 05 61 00 95 61 Tests & radiations Email: trad@trad.fr Web Site: www.trad.fr SIRET 397 862 038 00056 - TVA FR59397862038 Verified by / Quality control Written by Approved by E. LE GOULVEN A. VAROTSOU P. GARCIA 06/01/2015 09/01/2015 30/01/2015 Revision 0: First Issue dated of 16/07/2014 Revision 1: Multiple modifications following comments by C. Poivey and J. Ilstad of 17/09/2014 Revision 2: Add results of second campaign Revision 3: Multiple modifications following comments by C. Poivey of 10/12/2014 Project/Program: COO2 FSΔ To: **POIVEY Christian** Ref: ESA contract 4000105666

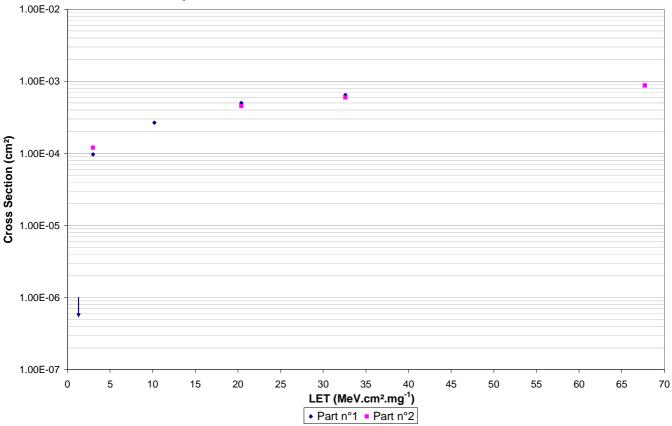
SEUs were observed during the irradiation down to the Neon Heavy Ion (LET = 3 MeV.cm²/mg).

Figure 20: Simple-Precision PARANOIA - SEU Corrected Errors cross section curve for AT7913

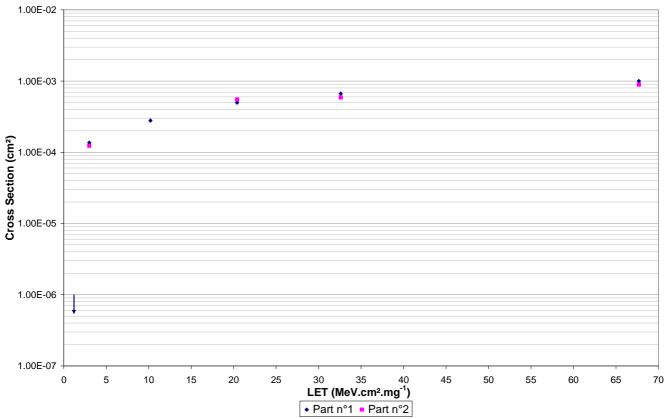
SEUs were observed during the irradiation down to the Neon Heavy Ion (LET = 3 MeV.cm²/mg).

Figure 21: FFT - SEU Corrected Errors cross section curve for AT7913

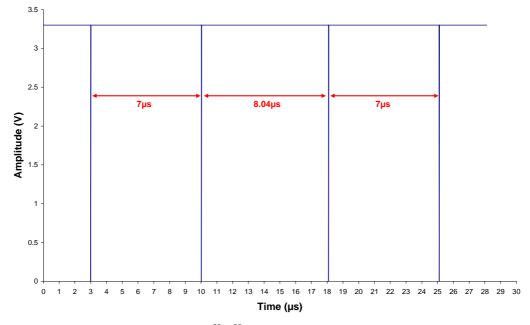
The event bellow shows that the duration between two pulse activations of WrN pin, was $8.04\mu s$ instead of $7\mu s$. This is the maximum gap between two activations of WrN. It occurs on Part N°1 during run n°20 event n°105 (Kr, 32.4 MeV.cm²/mg)

Figure 25: SET curve on WrN pin, Heavy Ion ⁸³Kr²⁵⁺ (LET of 32.4MeV.mg/cm²), Part 1, Run n°20, Event n°105

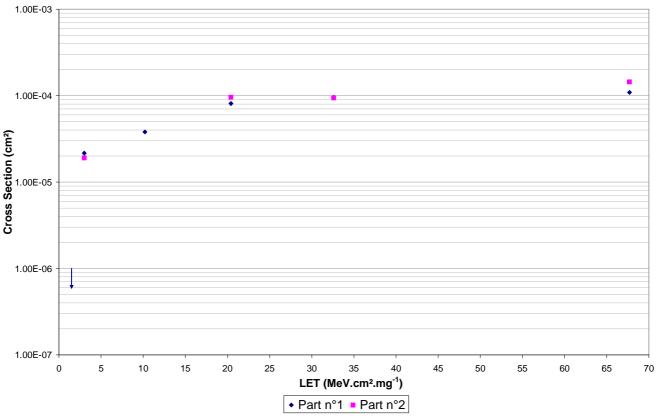
SETs for internal timer 1, were observed during the irradiation up to the Neon Ion (LET = 3 MeV.cm²/mg).

Figure 26: 32-bit timer SET cross section curve for AT7913

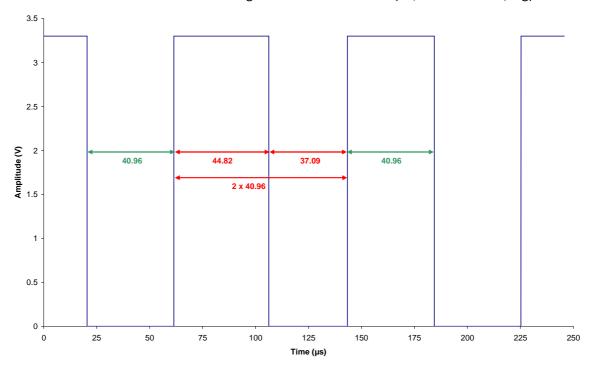
The worst SET case occurs on Part N°2 during run n°142 event n°117 (Xe, 67.7 MeV.cm²/mg).

Figure 27: SET curve Heavy Ion ¹²⁴Xe²⁶⁺ (LET of 67.7MeV.mg/cm²), Part 2, Run n°142, Event n°117

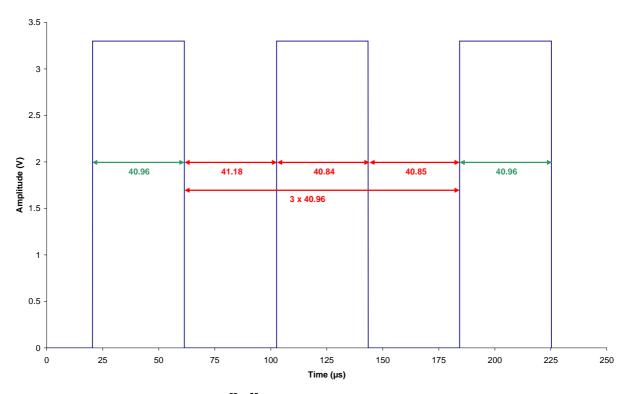
The worst SET case occurs on Part N°1 during run n°16 event n°44 (Kr, 32.4 MeV.cm²/mg).

Figure 28: SET curve Heavy Ion ⁸³Kr²⁵⁺ (LET of 32.4MeV.mg/cm²), Part 1, Run n°16, Event n°44

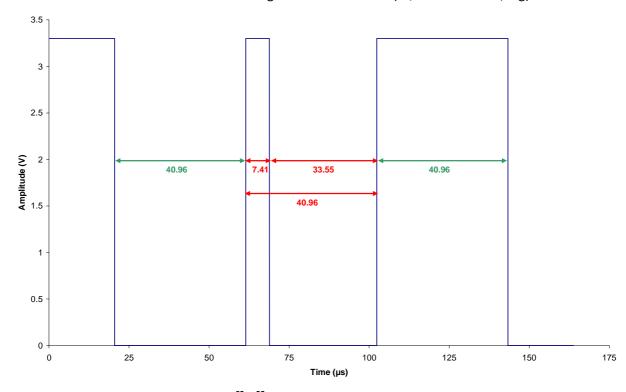
The worst SET case occurs on Part N°1 during run n°15 event n°2 (Kr, 32.4 MeV.cm²/mg).

Figure 29: SET curve Heavy Ion ⁸³Kr²⁵⁺ (LET of 32.4MeV.mg/cm²), Part 1, Run n°15, Event n°2

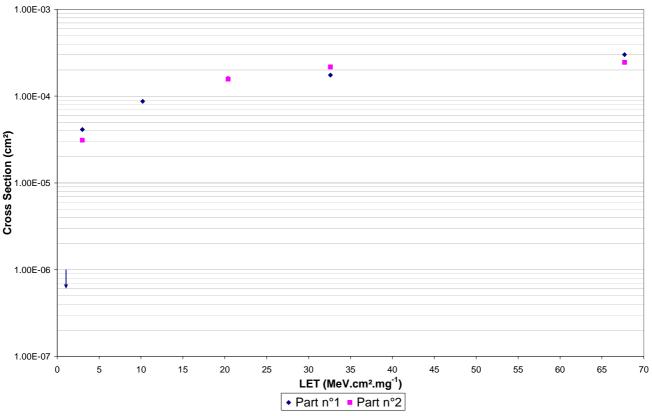
SETs on ADWr signal, were observed during the irradiation down to the Neon Ion (LET = 3 MeV.cm²/mg).

Figure 30: ADC/DAC Interface SET on ADWr cross section curve for AT7913

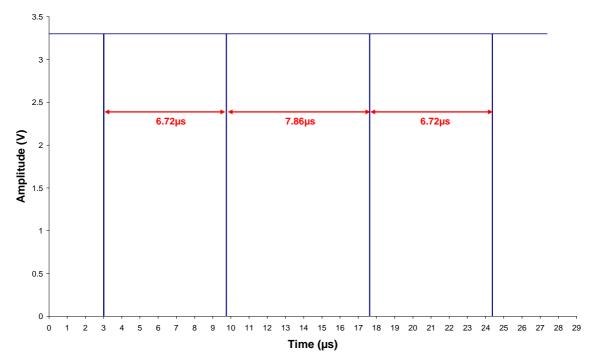
The maximum gap between two activations of WrN pin occurs on Part N°1 during run n°2 event n°140 (Kr, 32.4 MeV.cm²/mg).

Figure 31: SET curve on ADWr pin, Heavy Ion 83 Kr²⁵⁺ (LET of 32.4MeV.mg/cm²), Part 1, Run n°2, Event n°140

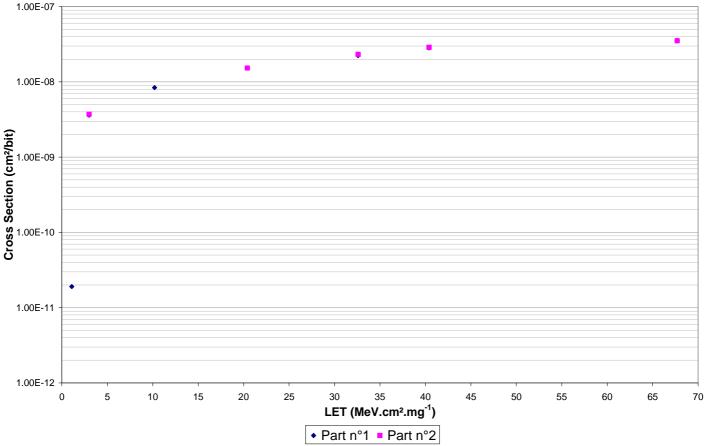
SEUs for the on-chip memory without EDAC protection, were observed during the irradiation down to the Carbon Ion (LET = $1.1 \text{ MeV.cm}^2/\text{mg}$).

Figure 33: On-chip Memory without EDAC SEU cross section curve for AT7913

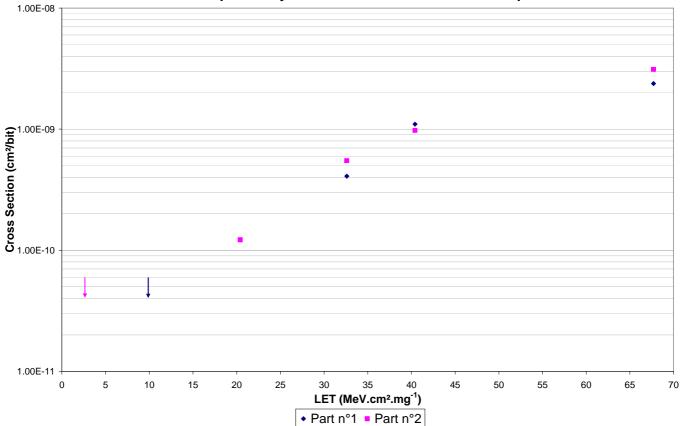
Figure 34: On-chip Memory with EDAC MBU cross section curve for AT7913

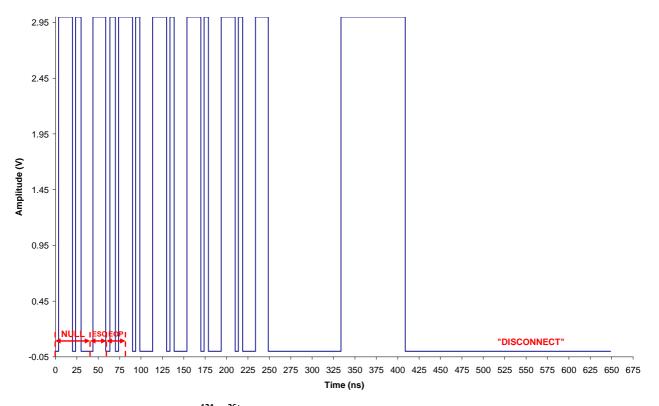
The SEU cases shown hereunder occur on Part N°2 with the Space Wire port 0 at 200MHz and one byte sending, during run n°153 (Xe, 67.7 MeV.cm²/mg).

Figure 37: SEU curve Heavy Ion ¹²⁴Xe²⁶⁺ (LET of 67.7MeV.mg/cm²), Part 2, Space Wire port 0, Data signal, Run n°153, ESCAPE-EOP.

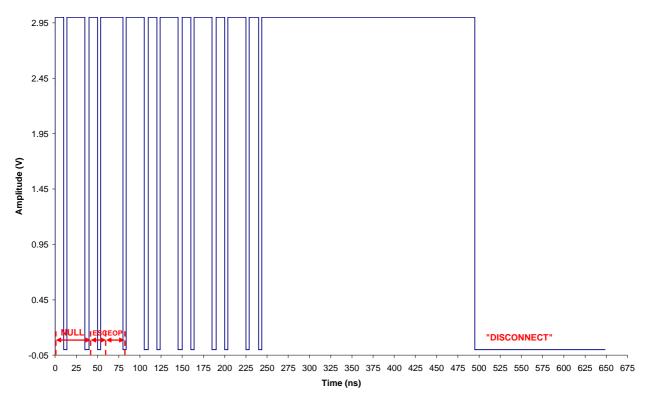
Figure 38: SEU curve Heavy Ion ¹²⁴Xe²⁶⁺ (LET of 67.7MeV.mg/cm²), Part 2, Space Wire port 0, Strobe signal, Run n°153, ESCAPE-EOP.

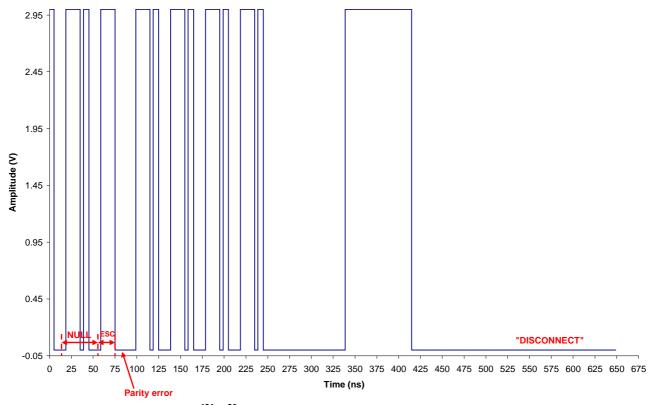
Figure 39: SEU curve Heavy Ion ¹²⁴Xe²⁶⁺ (LET of 67.7MeV.mg/cm²), Part 2, Space Wire port 0, Data signal, Run n°153, Parity Error.

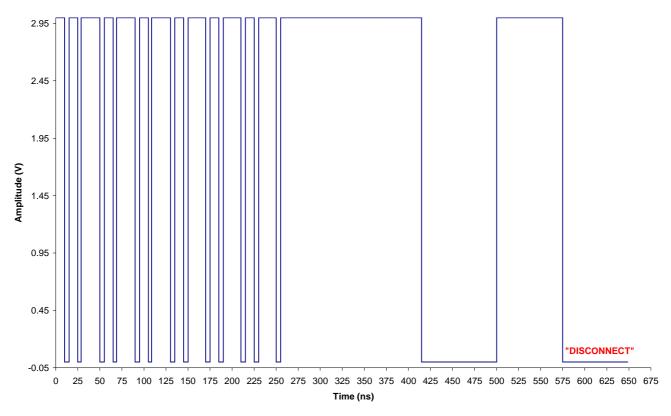
Figure 40: SEU curve Heavy Ion ¹²⁴Xe²⁶⁺ (LET of 67.7MeV.mg/cm²), Part 2, Space Wire port 0, Strobe signal, Run n°153, Event n°2, Parity Error.

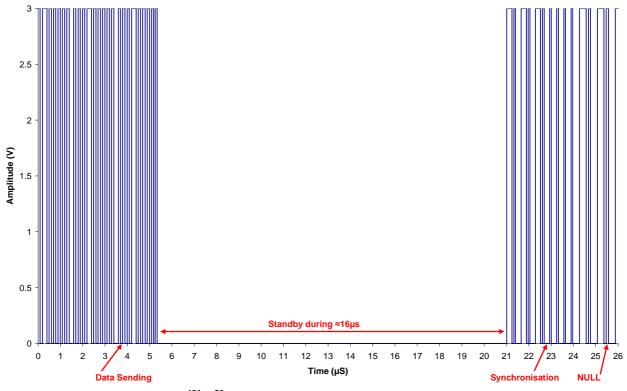
The SEU cases shown hereunder occur on Part N°1 with the Space Wire port 0 at 10MHz and 64Kbytes sending, during run n°127 (Xe, 67.7 MeV.cm²/mg).

Figure 41: SEU curve Heavy Ion ¹²⁴Xe²⁶⁺ (LET of 67.7MeV.mg/cm²), Part 1, Space Wire port 0, Data signal, Run n°127, Event n°2, Disconnect Error.

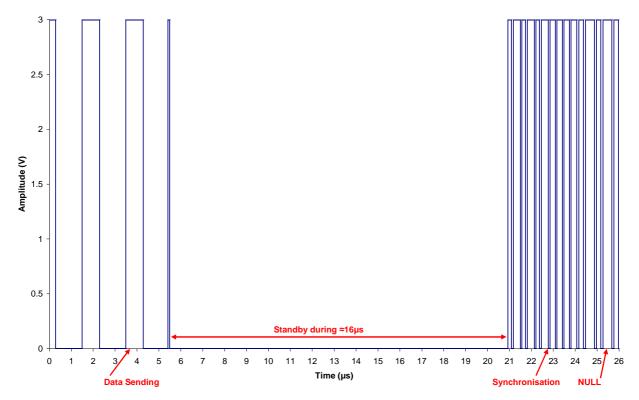
Figure 42: SEU curve Heavy Ion ¹²⁴Xe²⁶⁺ (LET of 67.7MeV.mg/cm²), Part 1, Space Wire port 0, Strobe signal, Run n°127, Event n°2, Disconnect Error.

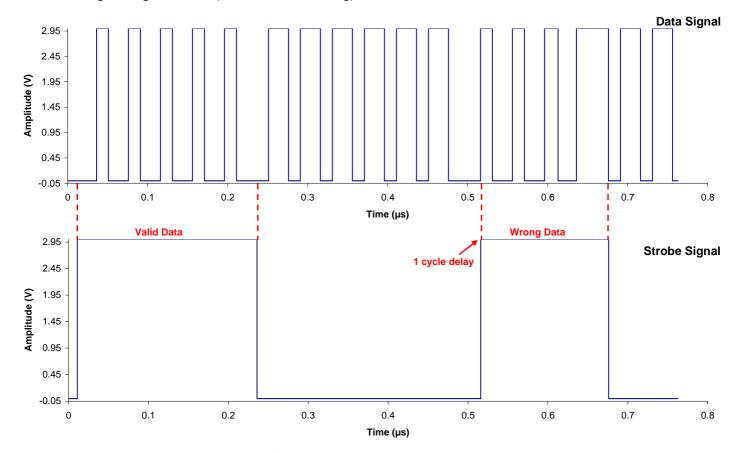
The SEU cases shown hereunder occur on Part N°2 with the Space Wire port 0 at 50MHz and 64Kbytes sending, during run n°150 (Xe, 67.7 MeV.cm²/mg).

Figure 43: SEU curve Heavy Ion ¹²⁴Xe²⁶⁺ (LET of 67.7MeV.mg/cm²), Part 2, Space Wire port 0, Strobe and Data signals, Run n°150, Event n°1, Parity Error.
