SEE test of the Intersil Quad CMOS Driver ISL7457SRHF, RADEF November 2014

Prepared by Véronique Ferlet-Cavrois
Reference ESA-TECQEC-LAB-TR-0758
Issue 1
Revision 2
Date of Issue 26/08/2015
Status Authorised
Document Type RP
Distribution

The following document describes the SEE (single event effect) test of the Intersil non-inverting, quad CMOS Driver ISL7457SRHF [RD1, RD2] with heavy ion broad beam at RADEF, Jyväskylä, Finland [RD3-RD4]. This experiment was undertaken to assess the worst-case SEE test conditions and the SEE sensitivity of this device.

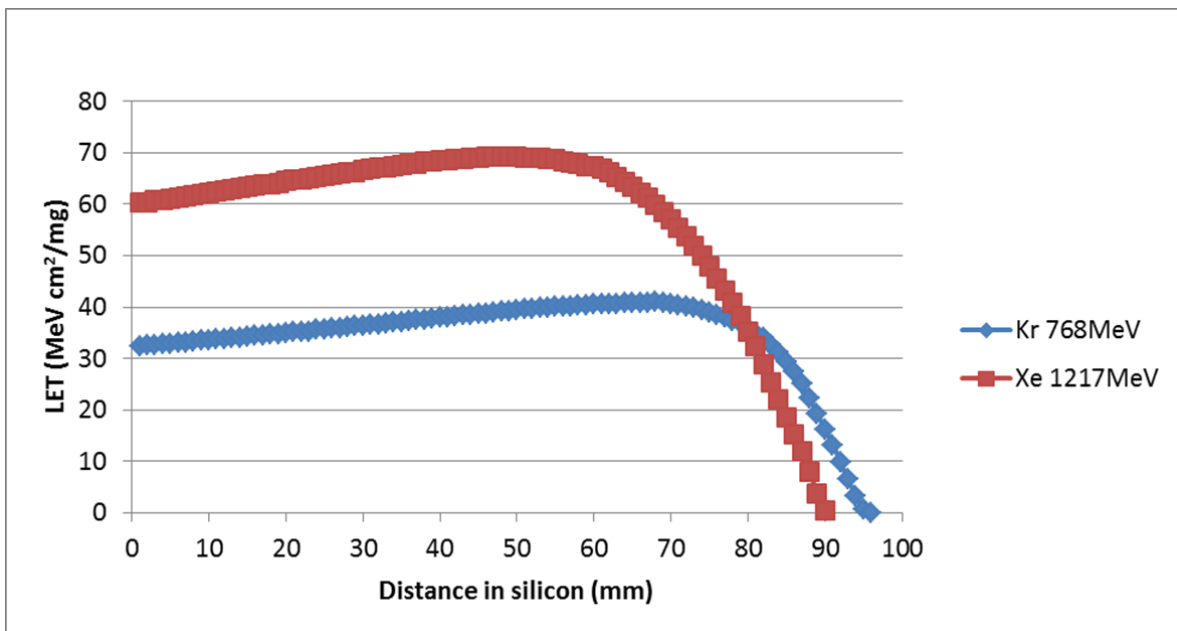
Ions: Kr 768MeV, in silicon: range 94 μ m, LET 32.1MeVcm²/mg

Xe 1217 MeV, in silicon: range 89 μ m, LET 60 MeVcm²/mg

Figure 2: LET vs. range in silicon for Kr and Xe used at RADEF during this experiment.

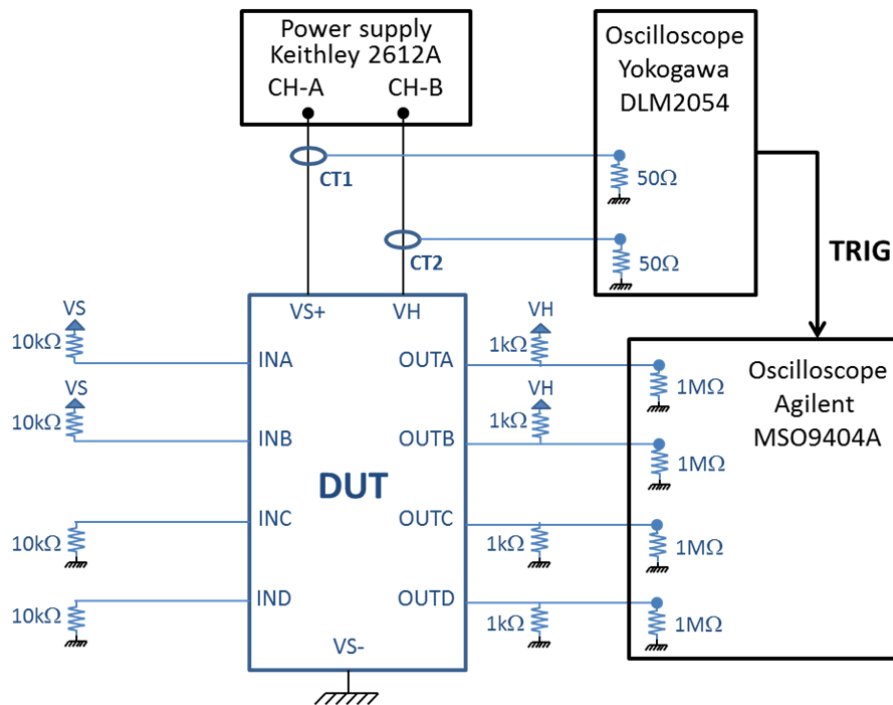
The Fig. 3 below shows the SEE test set-up. The single event transients (SETs) on VS and VH were detected with Tektronix current probes (CT2 $1\text{mV}/\text{mA}$ on VH and CT1 $5\text{mV}/\text{mA}$ on VS). The probes were connected to two 50Ω input channels of a Yokogawa DLM2054 oscilloscope. The Yokogawa was set to detect transients on both channels (VS or VH) and to externally trigger a second oscilloscope, Agilent MSO9404A, which was registering transients from OUTA, OUTB, OUTC and OUTD on its four channels (with $1\text{M}\Omega$ load input).

Figure 3: ISL7457 SEE test set-up.

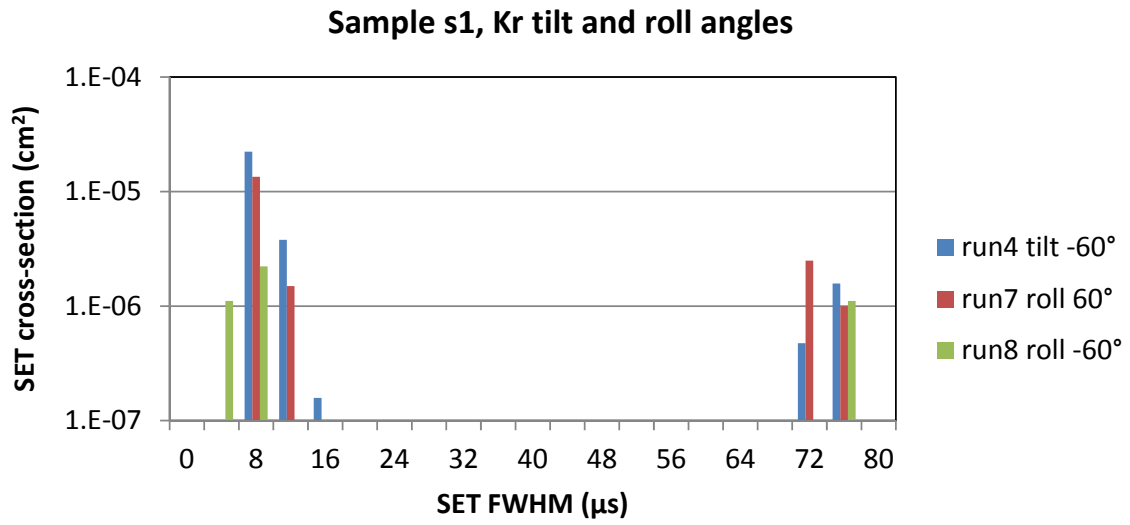
Sample s1 was irradiated with Kr ions at 15V. Different tilt and roll incident angles were employed in order to detect sensitivity to angling (see description of test runs in Appendix 1). No specific behaviour under tilt or roll angle was detected. The transients were correctly registered only from run4. Two distinct types of single event transients (SETs) were measured, either narrow or large, on the biased outputs, OUTA and OUTB, while no significant transients were measured on the grounded outputs, OUTC and OUTD. The histograms of the full width at half maximum of the SETs measured on OUTA of sample s1 during three runs are plotted in Fig. 4. The outputs OUTA and OUTB deliver similar histograms, with two distinct groups of transients, narrow (less than 20 μ s) or large (between 60 μ s and 80 μ s). There are numerous narrow SETs, while there are only few large SETs.

Figure 4: OUTA SET cross-section histogram of sample s1, as a function of the SET full width at half maximum (FWHM). Sample s1 was irradiated with Kr ions at different tilt and roll angles.

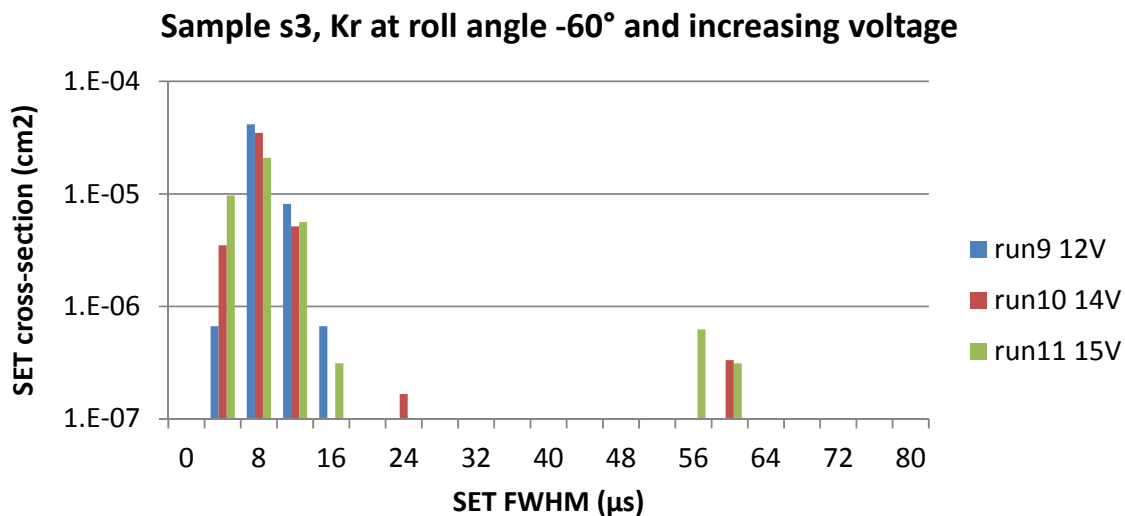
Sample s3 was irradiated with Kr ions at a roll angle of -60° at successively 12 V, 14 V and 15V supply bias. Again, two distinct types of transients were measured, either narrow or large, on the biased outputs, OUTA and OUTB, while no significant transients were measured on the grounded outputs, OUTC and OUTD. Fig. 5 show the histograms of the SET full width at half maximum measured on OUTA for runs 4-7-8. OUTB provides very similar histograms, with numerous narrow SETs and a few large SETs. Fig. 6a and Fig. 6b show examples of transients measured respectively on OUTA and OUTB during run 11 (VS = VH = 15 V). The transients #116 (black line) and #122 (green line) are examples of narrow transients, while transient #66 (blue line) is an example of large transient. Note that transients on the outputs (OUTA-B-C-D) are registered synchronously when a transient is detected on the VH or VS supplies. Interestingly, OUTA and OUTB displays the same type of transients. For example, the #66 OUTA and OUTB transients are both large transients, not perfectly identical, but very similar in width, amplitude and shape. The #116 and #122 OUTA and OUTB transients are both narrow and with very similar shape. Transient #123 has a particular shape: it corresponds to the device burn-out. OUTA and OUTB voltages saturate at about 12.5 V instead of 15 V. The burn-out reduced the impedance of the output stage to 1.25 k Ω (10 mA leakage current for 12.5 V bias), instead of 500 k Ω (about 30 μ A leakage current for 15 V bias) in normal conditions. The burn-out is also revealed by a sharp increase of the VH supply current reaching the power supply current limit value of 10mA.. Under microscope the failure on sample s3 is located in the protection structure attached to OUTA (see Appendix 2).

Figure 5: OUTA SET cross-section histogram of sample s3, as a function of the SET full width at half maximum (FWHM). Sample s3 was irradiated with Kr ions at -60° roll angle, and at increasing supply voltage (12 V, 14 V, 15 V).

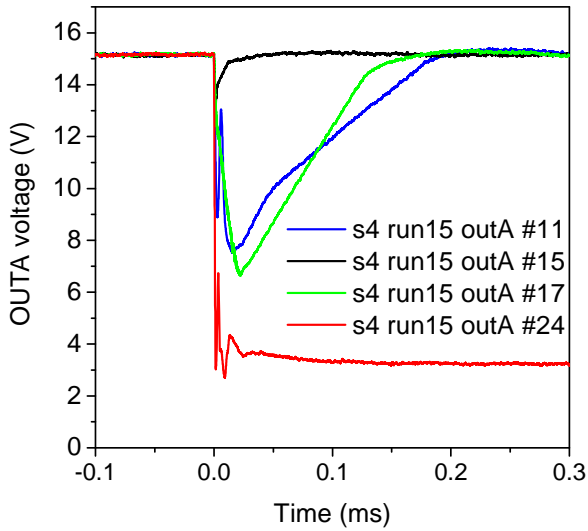
a) Sample s3, run11, OUTA

b) Sample s3, run11, OUTB

c) Sample s4, run15, OUTA

d) Sample s4, run15, OUTB

Figure 6: Examples of SETs measured on OUTA and OUTB of sample s3 and s4 biased at 15V ($V_S = V_H = 15V$), respectively under Kr (roll angle 60°) and Xe (normal incidence). The other outputs, OUTC and OUTD, were grounded and did not show significant transients.

Examples of narrow and large transients measured on OUTA and OUTB are shown in respectively Fig. 6c and Fig. 6d for run15 ($V_S = V_H = 15$ V). Transient #15 is a narrow transient, while transients #11 and #16 are large transients. At half maximum, large SETs are about 60-80 μ s, but the full width of the large SETs is at least twice larger, from 0.12 ms up to close to 0.2 ms. The last transient #24 shows the device burn-out, with V_H voltage saturating at about 3 V after failure, instead of 15 V before failure. The burn-out reduced the impedance of the output stage to 0.3 k Ω , lower than for sample s3 (1.25 k Ω). It is believed that the cause of the burn-out is due to one of the large SETs.

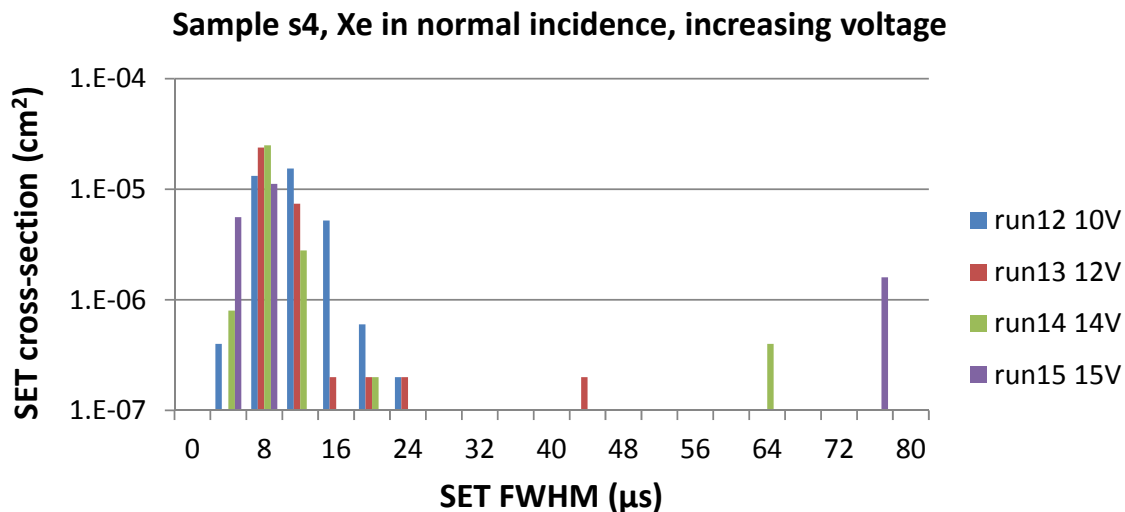
Sample s4 was irradiated with Xe ions at normal incidence at successively 10 V, 12 V, 14 V, and 15 V. Fig. 7 shows the histogram of the OUTA SET full width at half maximum, with as before, two groups of SETs: one group of numerous narrow SETs and a second group of few large SETs. It seems that the width of the large SETs increases with the supply voltage. No definite conclusion may be drawn due to insufficient statistics.

Figure 7: OUTA SET cross-section histogram of sample s4, as a function of the SET full width at half maximum (FWHM). Sample s4 was irradiated with Xe ions in normal incidence, and at increasing supply voltage (10 V, 12 V, 14 V, 15 V).

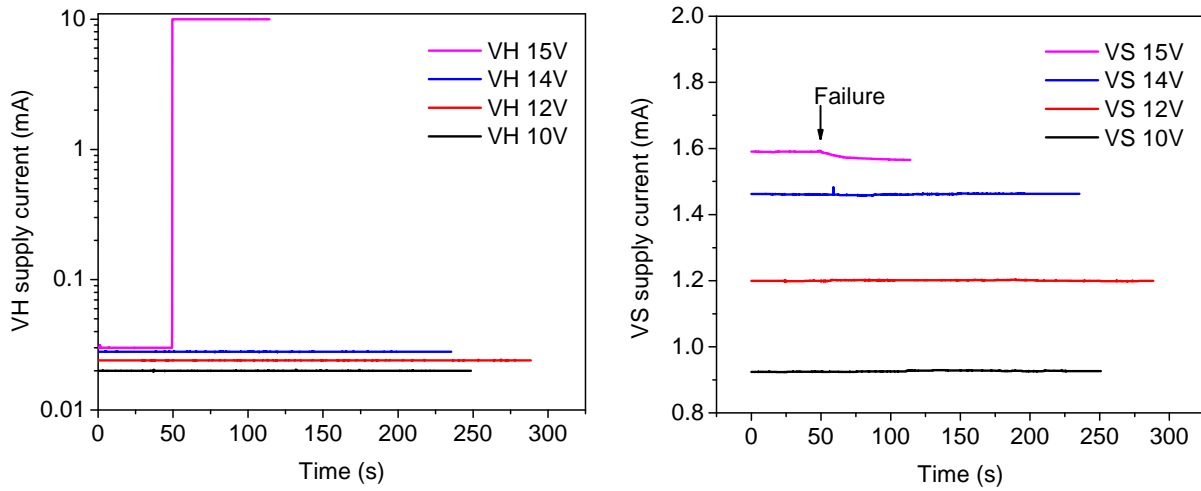
V_S and V_H supply currents of sample s4 show the same failure signature as for all devices (Fig. 8): A sharp increase of the V_H supply current was observed reaching the power supply current limit value of 10mA, while the V_S supply current is barely affected, with only a slight decrease.

Figure 8: VH and VS supply currents during irradiation measured on sample s4. Note that the supply currents are continuously registered from about 20s when the device is biased before the irradiation starts, during irradiation, and until about 10s after irradiation.

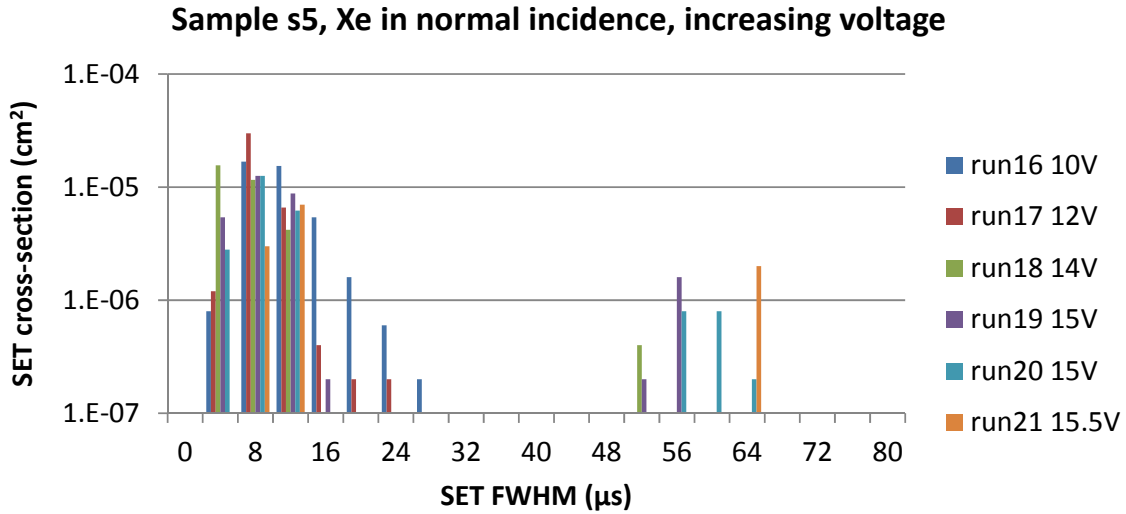
Sample s5 was irradiated with Xe ions at normal incidence at successively 10 V, 12 V, 14 V, and 15 V. Fig. 9 shows the histogram of the OUTA SET full width at half maximum, with as before, two groups of SETs: one group of numerous narrow SETs and a second group of few large SETs. It seems again that the width of large SETs increases with the supply voltage, but the statistics of large SETs is low.

Figure 9: OUTA SET cross-section histogram of sample s5, as a function of the SET full width at half maximum (FWHM). Sample s5 was irradiated with Xe ions in normal incidence, and at increasing supply voltage (10 V, 12 V, 14 V, 15 V, 15 V, 15.5 V).

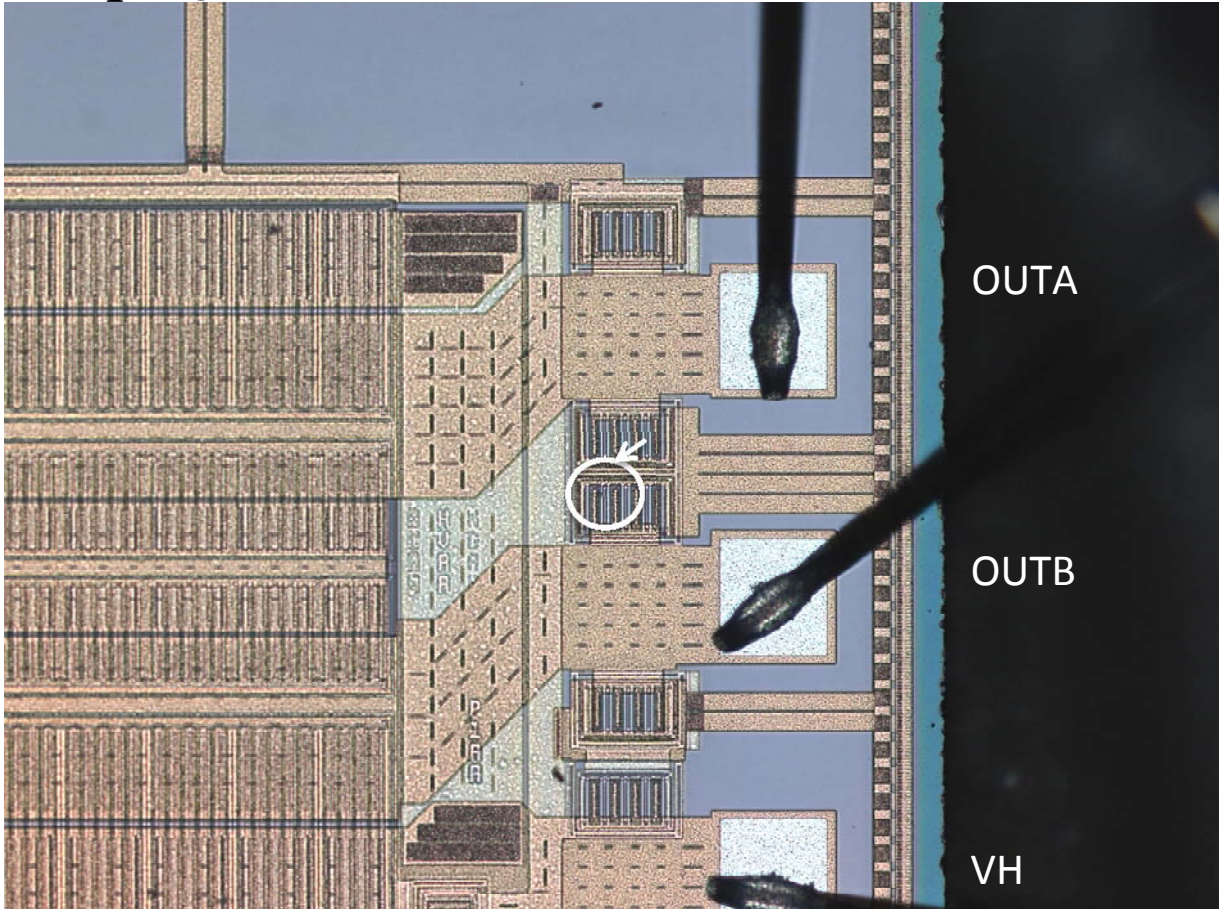
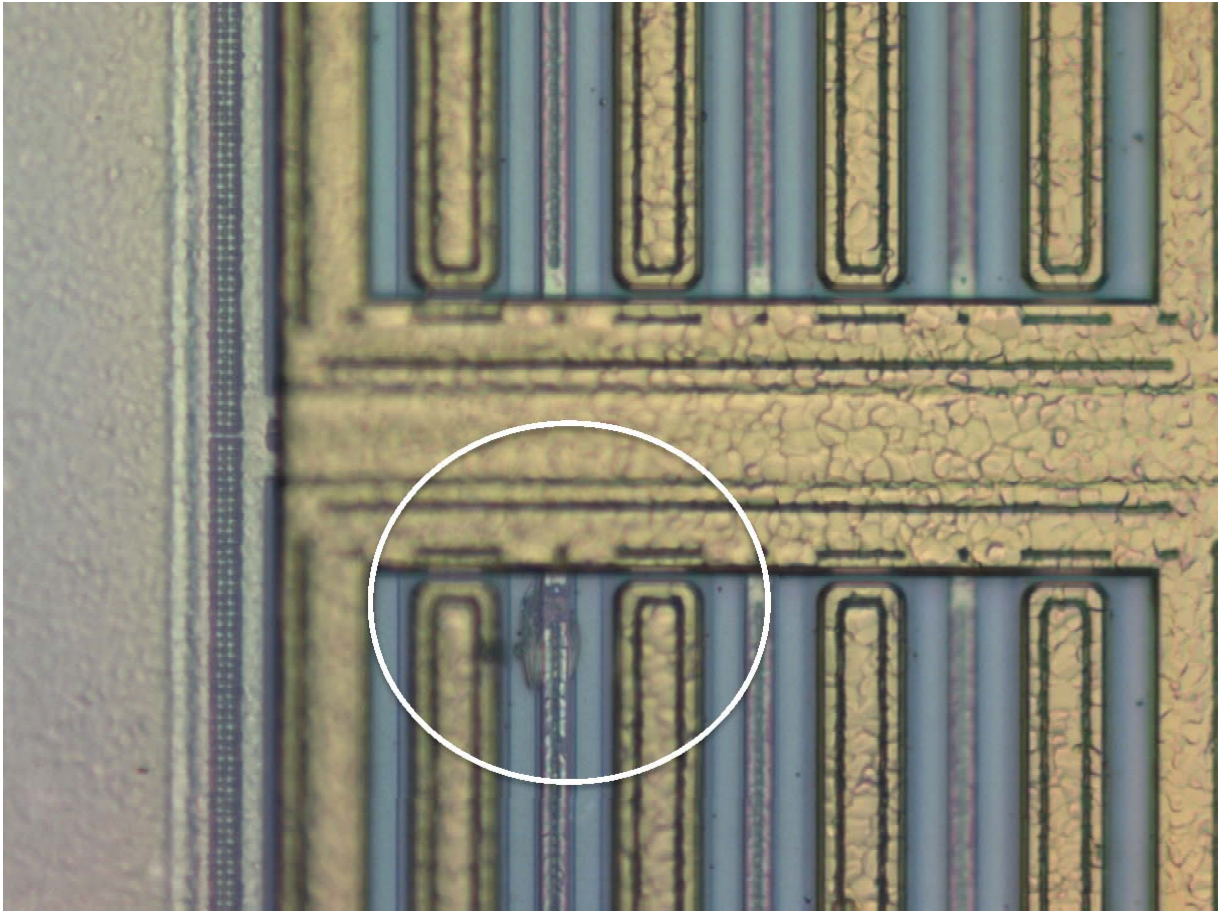
Sample 5

Sample s5 failed at a fluence of $1E6$ Xe ions/cm² and for a high supply voltage 15.5 V. The SEB voltage for this sample is higher than for the others (15 V), because it received the largest dose (25 krad). This illustrates the dose effect explained above.

The SEB sensitivity appears to be located in the protection structures attached to the device outputs, as observed for three of the irradiated samples. These protection structures are presumably off-state (gate grounded) MOS transistors. They fail by burn-out under heavy ion irradiation when the output is in high state. For two of the samples the failure site could not be visually located, indicating that the failure damage is either too small or hidden by the upper layer of the back-end-of-line. The failure mode in the ISL7457/PROTO is different from the previous version of the device EL7457 for which failures were located in the power MOSFET.
