Intelligent Memory heavy-ion SEE test report

Project: RHM WP 3300

Doc.no.: RHM-IDA-TN3-5

On September 20, 2017, a test was performed at RADEF to determine the sensitivity of Intelligent Memory DDR3 SDRAM devices to single-event effects (SEUs and SEFIs) caused by heavy-ion irradiation.

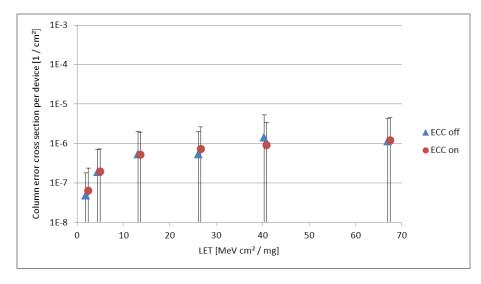
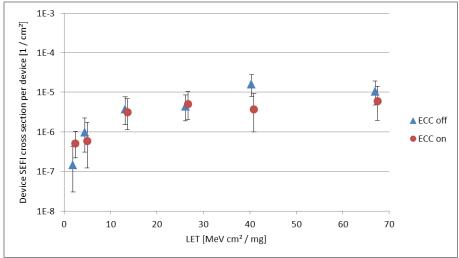
The error cross sections with ECC on and ECC off are shown in the following figures. In cases where the number of errors was zero, the shown value is the cross section that would have resulted from one error; this case can be recognized by the lower error bar which extends all the way to 0 ($-\infty$ in the logarithmic plot). The values are slightly shifted in the horizontal (LET) direction to make them more visually distinct; this does not correspond to an actual change in LET.

With error correction on, almost all runs had exclusively type-A block errors; with error correction off, almost all runs had exclusively type-B block errors (note that block errors are more severe with error-correction enabled). A few runs (3 with error correction off and 1 with error correction on, out of 92 total) had both types of block errors.
