Single Event Effects

Proton Test Report

Test type	Single-Event Upset, Single Event Latchup
Part Reference	4B4G0846Q
Tested function	DDR3L SDRAM
Chip manufacturer	Samsung
Test Facility	PIF, Paul Scherrer Institute (PSI), Villigen, Switzerland
Test Date	May 2018
Customer	ESA ESTEC

Hirex reference :	HRX/SEE/00696	Issue : 01	Date :	26/02/2019
Written by :	F. Lochon / F.X. Guerre			
Authorized by:	F.X. Guerre	Study Manager

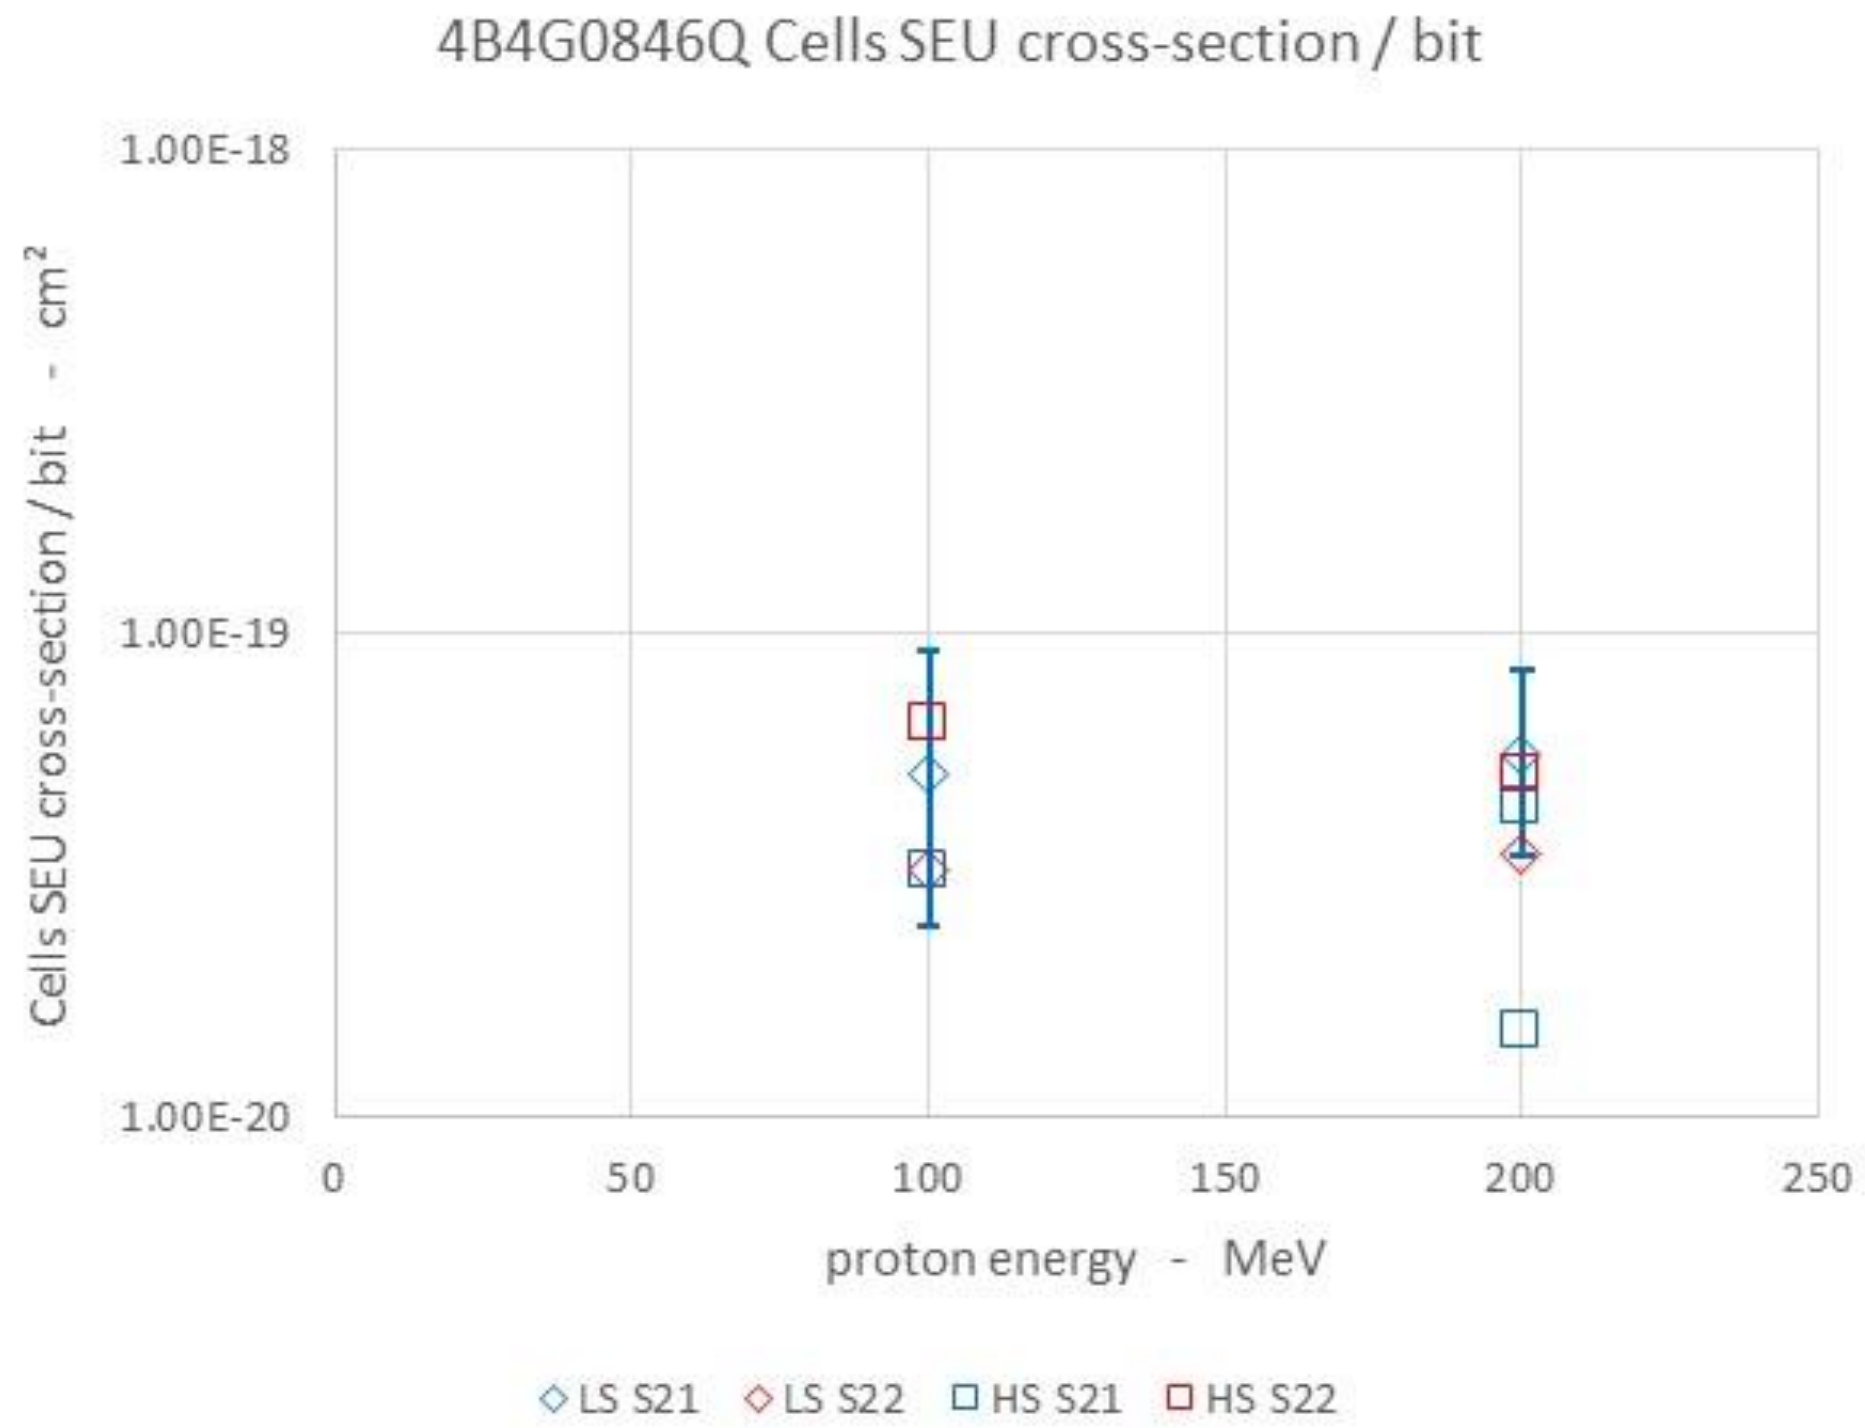
Figure 8 - Cells SEU cross-section / bit plot

<u>Pre-run errors</u>
Stuck bits present before exposure. They could have been created during previous runs on the DUT.
<u>R1 bit errors</u>
Number of errors detected during READ1 but not during READ2. None of these errors which represent reading errors have been detected.
<u>R1/R2 bit errors</u>
Number of errors detected during READ1 and during READ2. These errors represent SEU WRITE bit errors or SEU cells errors occurring during the time the cell is not written (as for instance during WAIT step but not only).
<u>R2 bit errors</u>
Number of errors detected during READ2 only: These errors represent reading errors which are expected to be quite few as for R1 bit errors and the SEU cells errors occurring during the time the cell is not read.
<u>Persistent bit errors</u>
Bit errors that last more than one sequence iteration. Part of these errors can persist up to the end of the run and are then counted as post-run bit errors (stuck bits). Pre-run errors have been subtracted from the persistent bit error count.

The corresponding cross-section are plot in Figure 8 and Figure 9 .

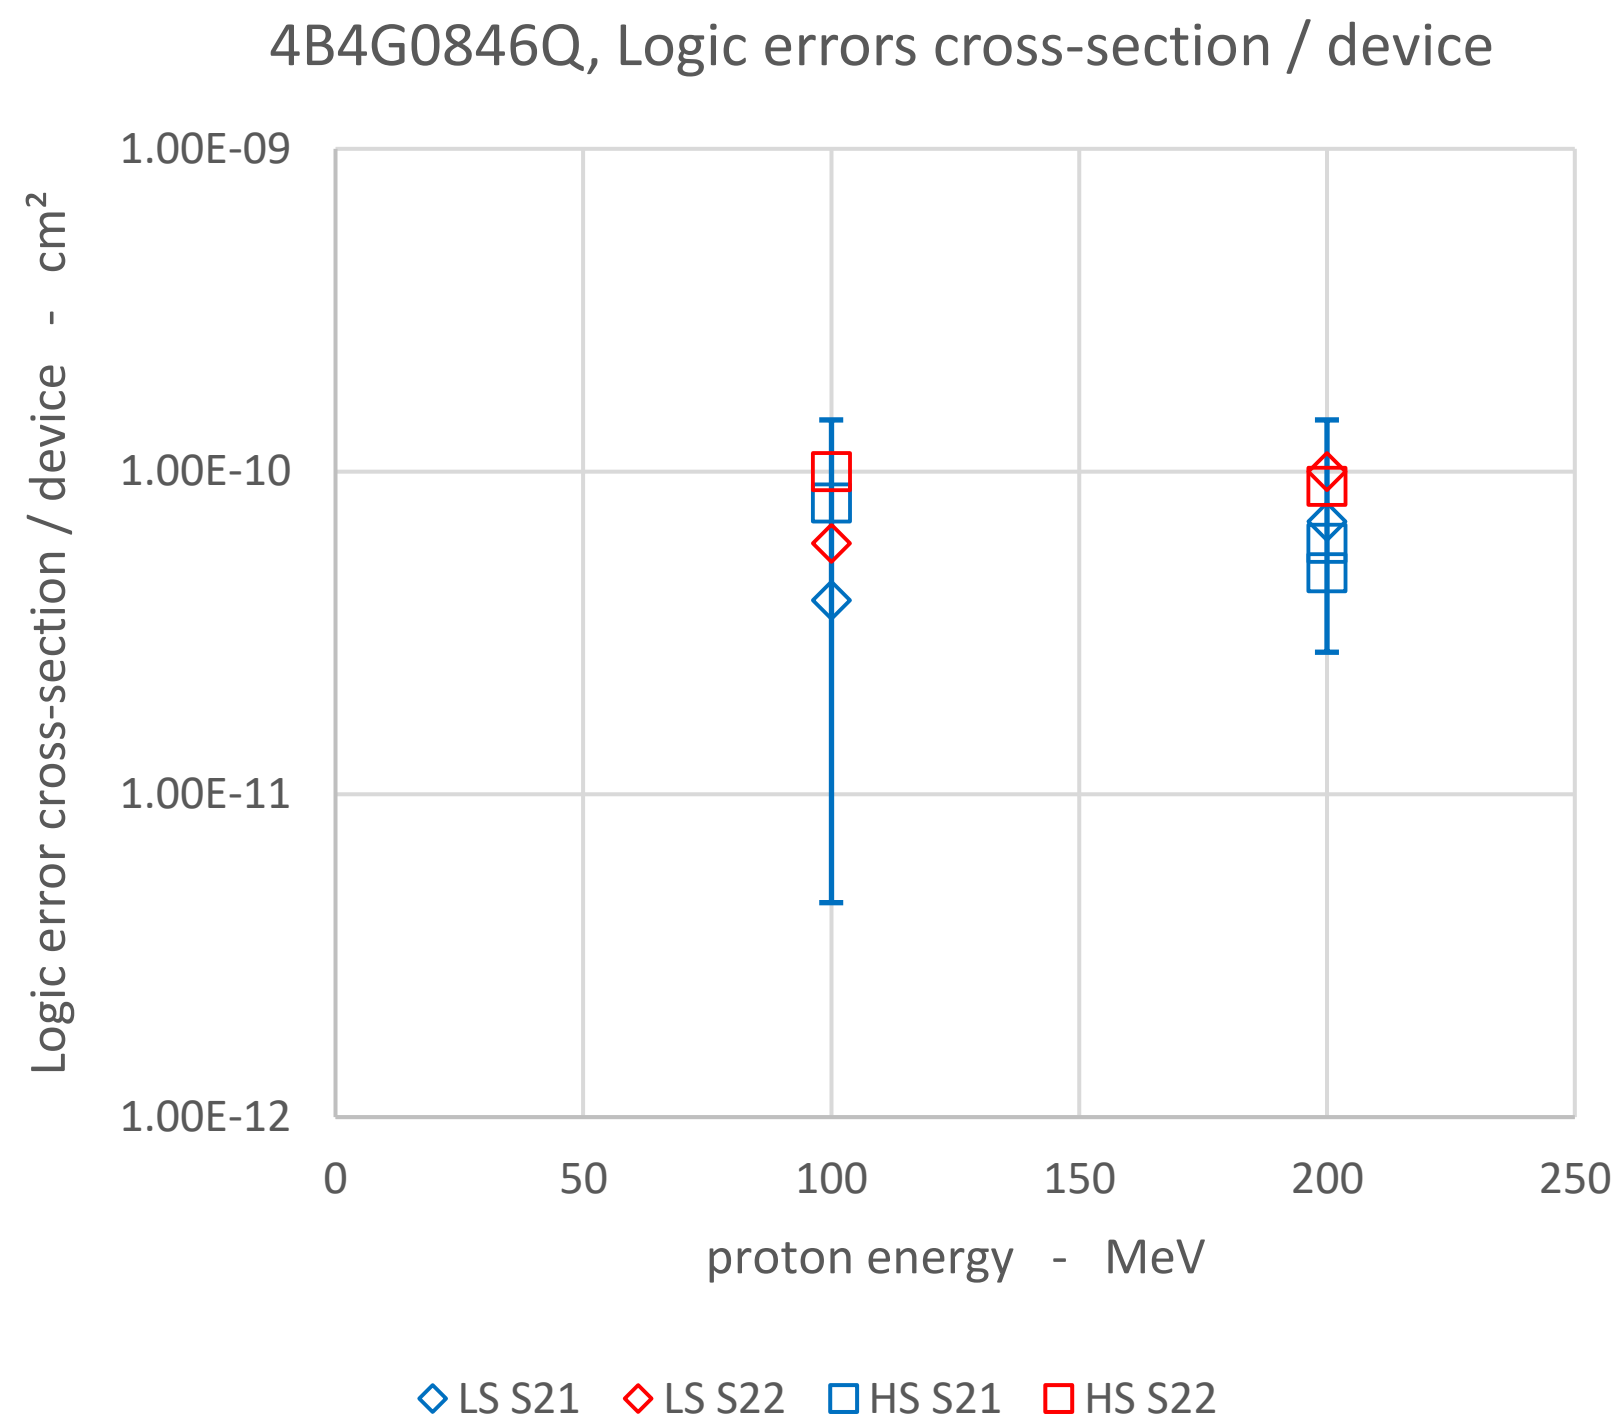
Figure 9 – Logic errors cross-section / device plot

<u>Colum error</u>
Likely an error in the logic.
<u>Row errors</u>
Likely an error in the logic. Consist in a portion of row in error in a bank.
<u>SEFI</u>
These errors consist mainly in column or row errors that persist during several sequence iterations. Majority has been cured by a manual power reset.
<u>Post-run bit errors</u>
The errors are stuck bits. All affected words are single bit upset.

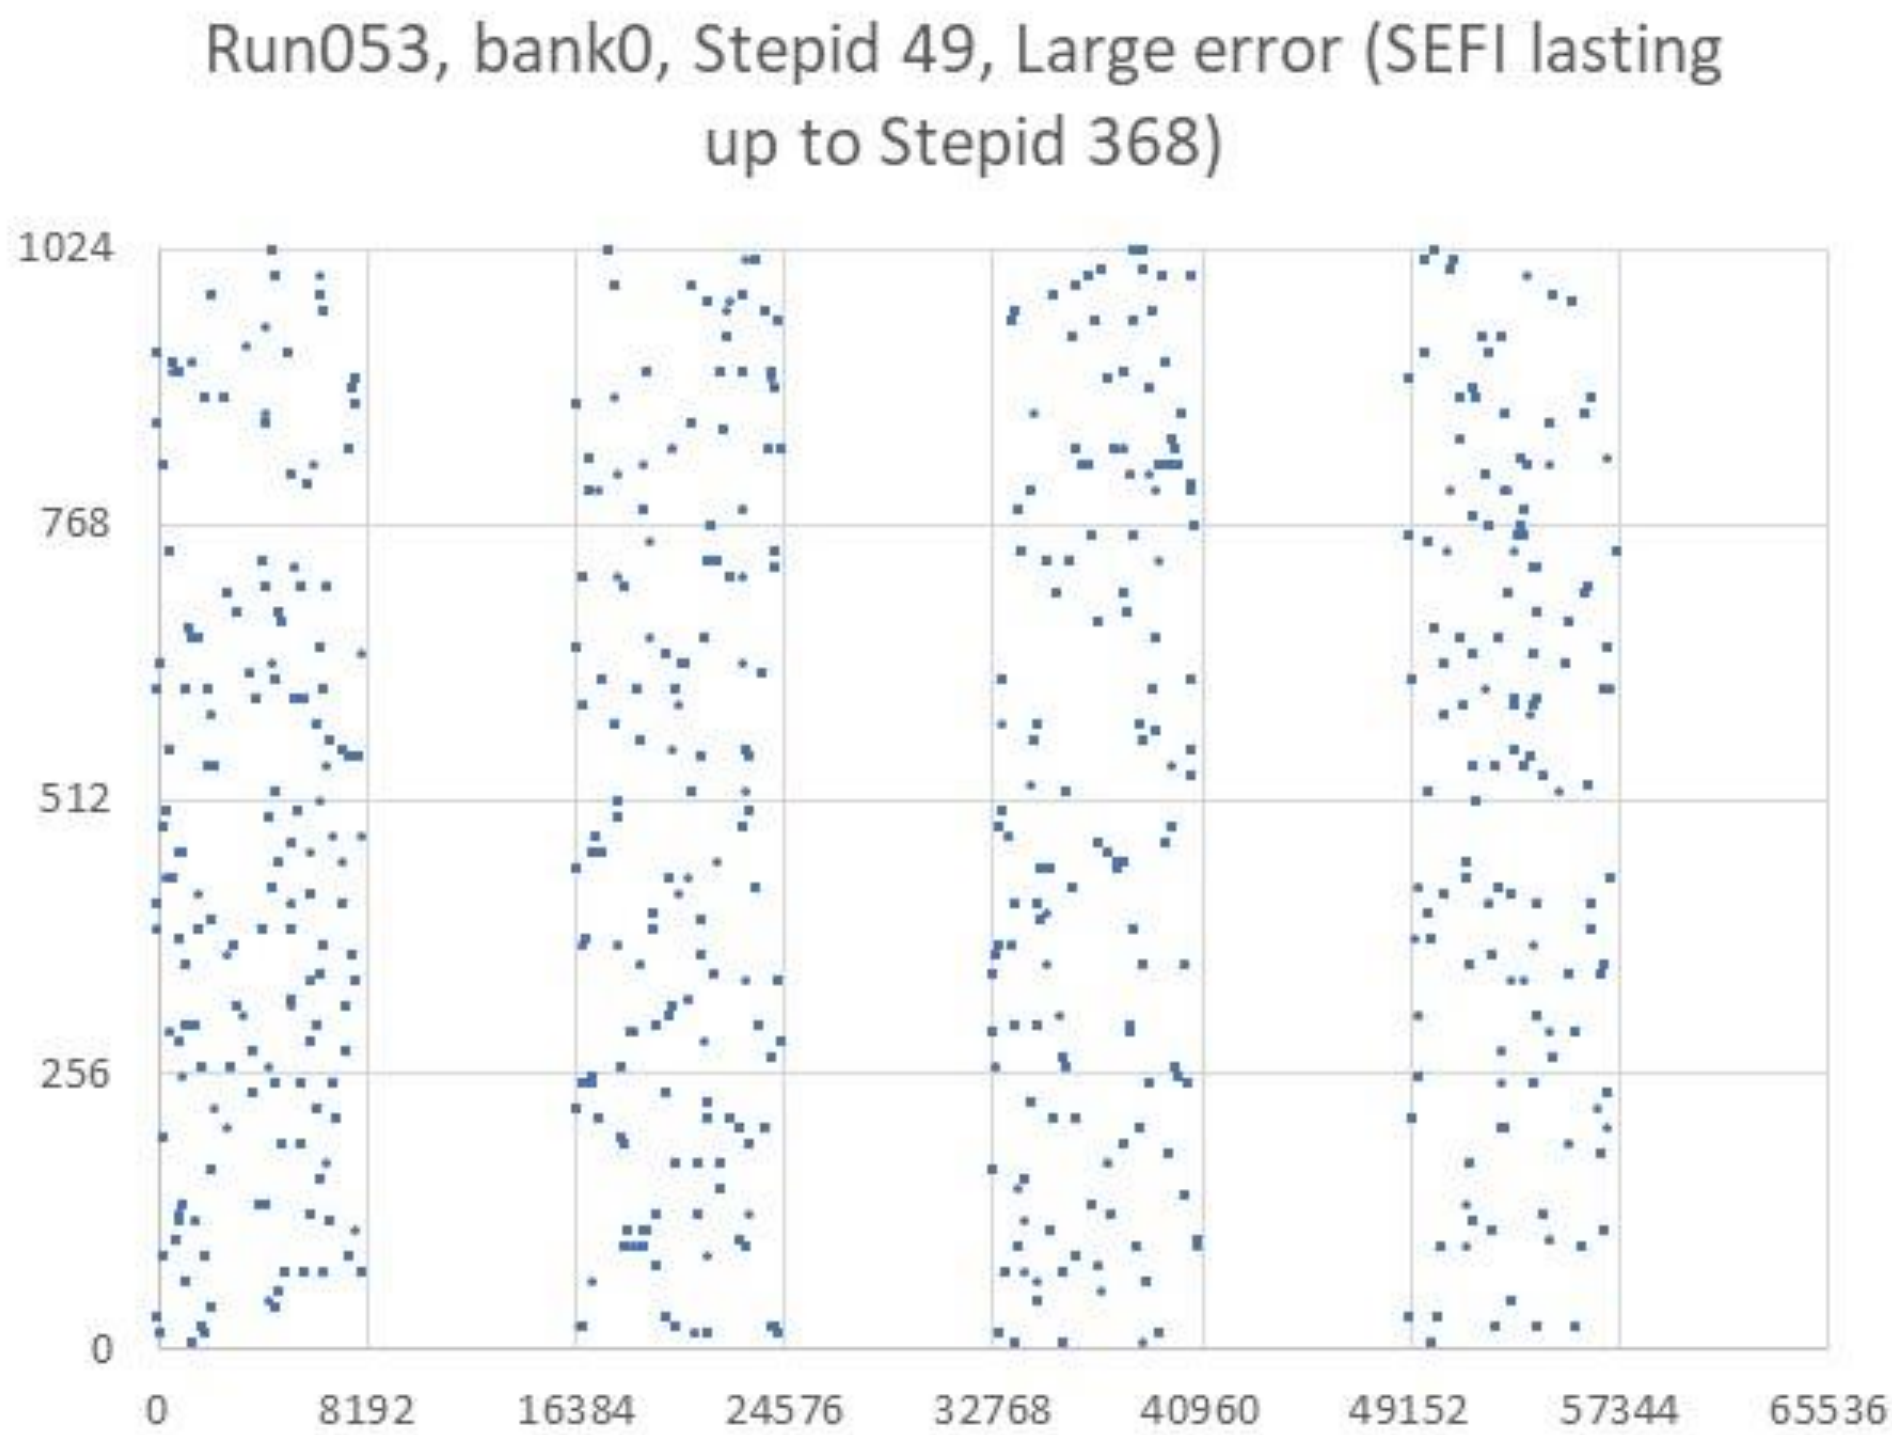
Figure 10 – run053, bank0, stepid 49, error mapping

During Run053 A large error, neither a column nor a row, has been detected and is plot in Figure 10. Same error pattern was also observed with heavy ions and only with Samsung.
All addresses in error are single bit error and error transition is always 1->0.
