Radiation tests ASTRO-H reference samples at ESA

Purpose of the study.

The purpose of this study is to check the radiation resistance of a set of 10x10x40 mm BGO reference crystals used for cutting Astro-H crystals on their radiation resistance against Co-60 gamma rays. These samples were tested at NICC on their resistance against hard UV light.

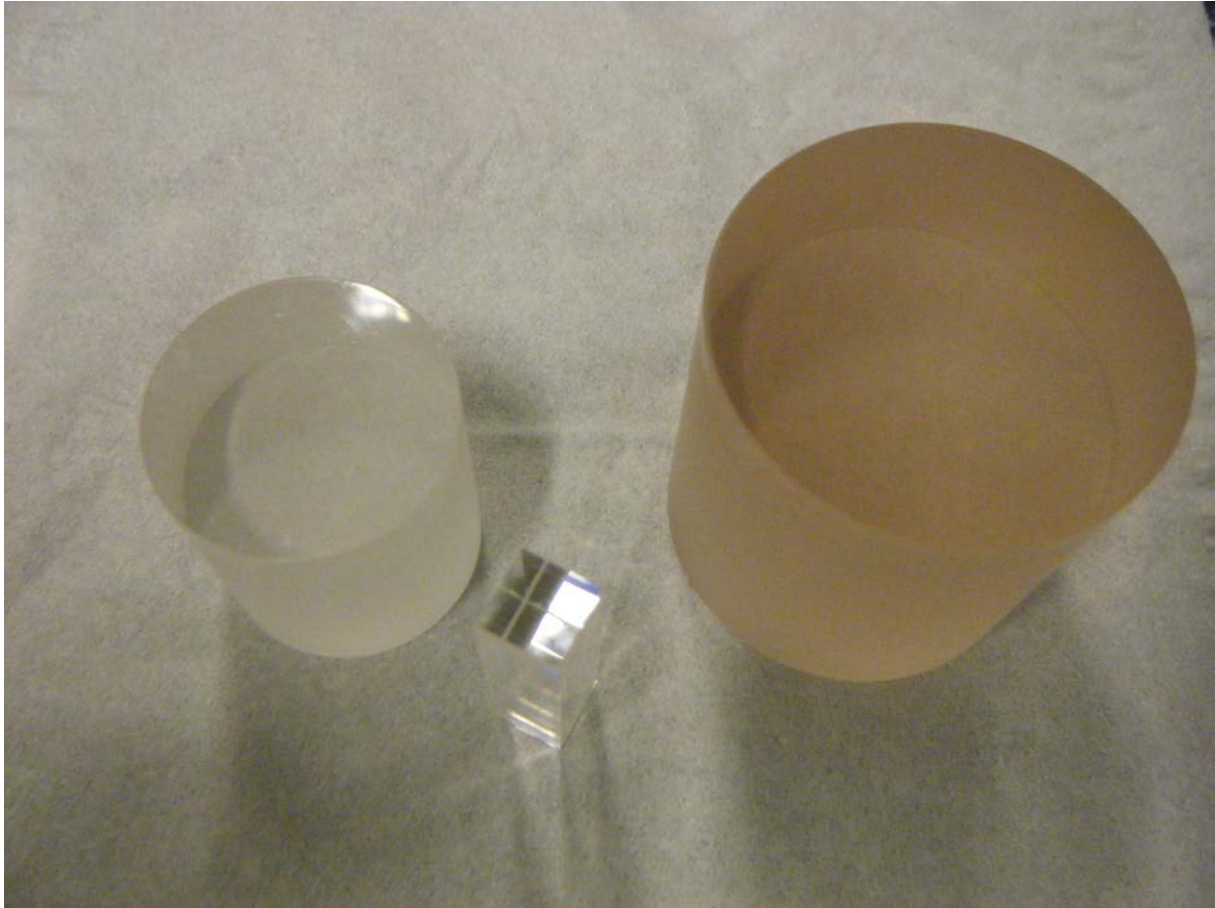
20 kRad Irradiated samples 12,4 and 11 (from left to right)

Note the very strong decrease in light output of the **Chinese crystal sample 11** which turned brown/pink after 20 kRad
